# RUGER PRECISION RIFLE®

## PRODUCT SAFETY BULLETIN

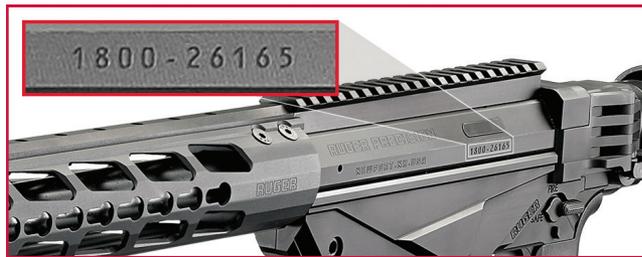
Ruger Precision Rifles (regardless of caliber) that have an aluminum bolt shroud and fall within the following serial number ranges are potentially affected:

**1800-26274 to 1800-78345** OR **1801-00506 to 1801-30461**

This Safety Bulletin does **NOT** apply to Ruger Precision Rifles with polymer bolt shrouds.

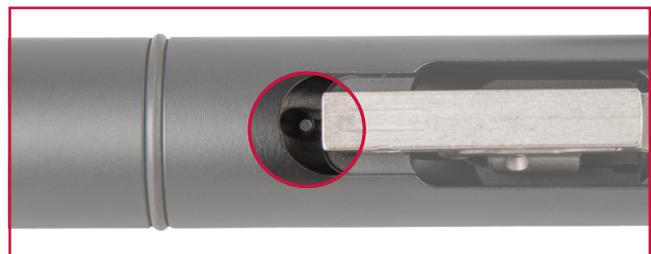
Replacement bolt shrouds of the new design are easily identified by the presence of a round dimple on the angled surface directly behind the firing pin back.

If your bolt shroud has this mark, it was manufactured with the new design and **no further action is needed**.
